**GROUP CHAIRMAN'S FACTUAL
REPORT OF INVESTIGATION
SOUND SPECTRUM STUDY**

Sound Spectrum Study

DCA-96-MA-070

Location: East Moriches, New York
Date: July 17, 1996
Time: 2031:12 Eastern Daylight Time
Aircraft: Trans World Airlines Inc.
Boeing 747-131 N93119

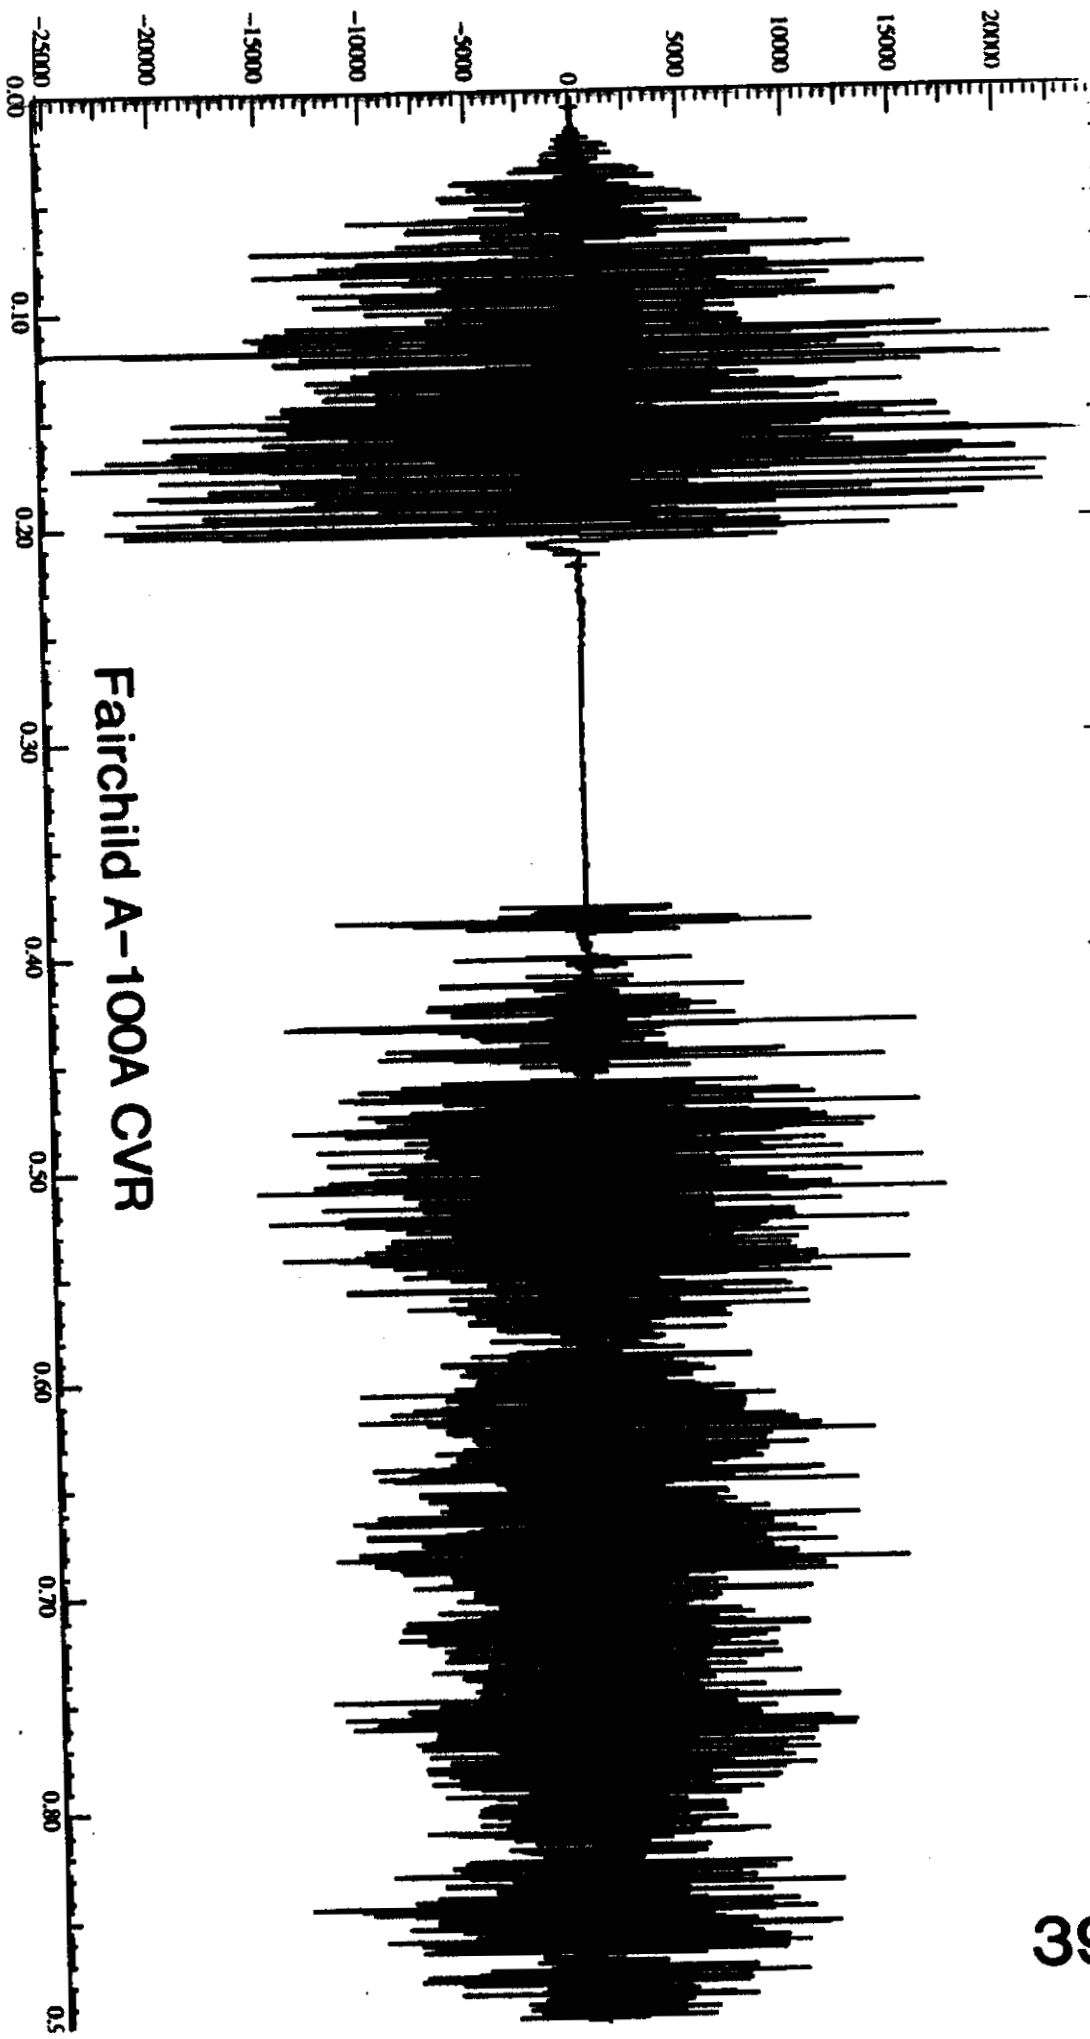
The final test in the trial was to explode a fuel-air mixture in the center wing fuel tank of the Boeing 747 aircraft. This test was conducted by injecting propane into the center wing tank to obtain a 3.2% propane/air mixture. The tank was ignited by placing a small high explosive device on the rear spar of the aircraft. The same CVR recorders and instrumentation were used to document the tank explosion. Chart 28 depicts the same 6 traces which represent the charge initiation (T_0), cockpit pressure, cockpit acceleration, cabin acceleration, Fairchild A-100A CVR, Fairchild A-100 CVR. Chart 29 depicts an expanded trace of the Fairchild A-100 CVR record and chart 30 depicts an expanded trace of the Fairchild A-100A CVR. Chart 31 depicts the sound data from the Fairchild A-100 CVR in addition to the power/energy distribution plot similar to what was shown on charts 18-22.
